# Manhole Inspection Summary

Manhole # S02GG2012MH

Insp Date: **7/18/06 9:14 AM**

**Location** Address: **6712 WESTBROOK RD**

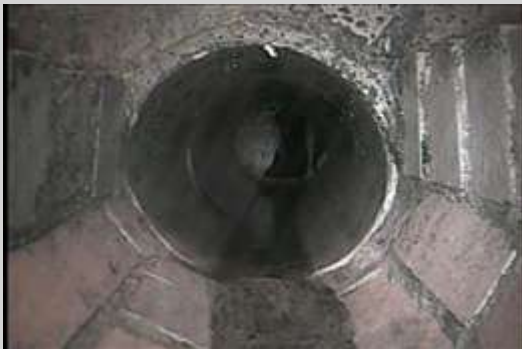
### 8 in. Circular Gravity Sewer Pipe In @ 5 O'Clock

Pipe Material: **Clay** ☐ Pipe Lined

Invert Depth: **10.55** (ft.) Flow Characteristics: **Slow**

Infiltration: **None** Pipe Seal Cond: **Unknown**

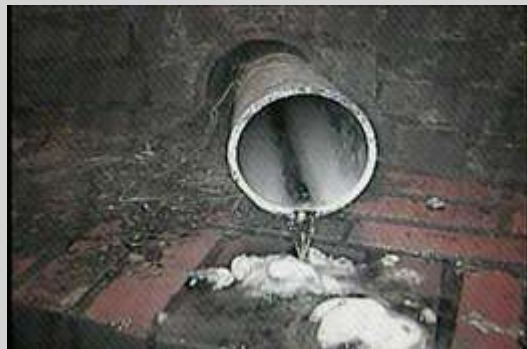
4 in. Circular Gravity Sewer

Pipe Material: **PVC**

Infiltration: **None**
